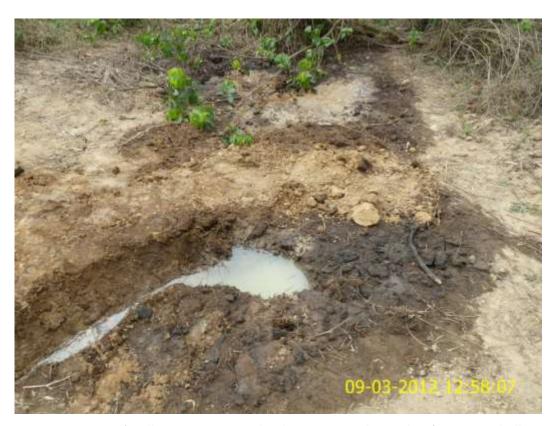
Overview: Part of spill impact on 24" Nkpoku-Bomu pipeline right of way at Egballor. Picture was taken during Joint Investigation of 9th March 2012.

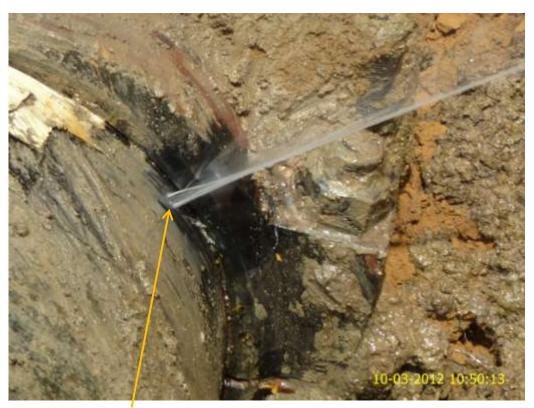
<u>Close up:</u> Hacksaw cut on 24" Nkpoku-Bomu pipeline at Egballor. Picture was taken during Joint Investigation of 10th March 2012.
