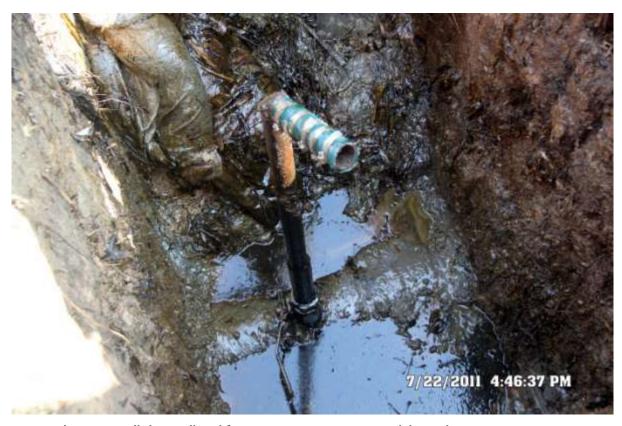
<u>Close-up:</u> Spill due to illegal fitting on 10" Ogini-Eriemu delivery line at Ogini. Picture taken during Joint Investigation of 22nd July, 2011
