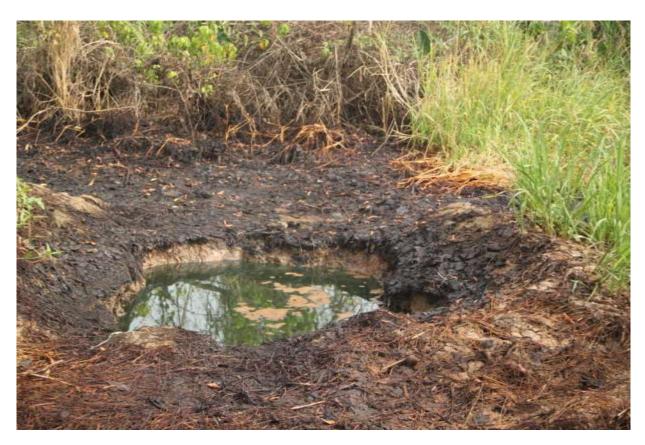
Overview: Extent of the spill incident impact on 12" Benisede - Isampou Pipeline route at Ekeremor. Picture was taken during JIV of 19 January 2011

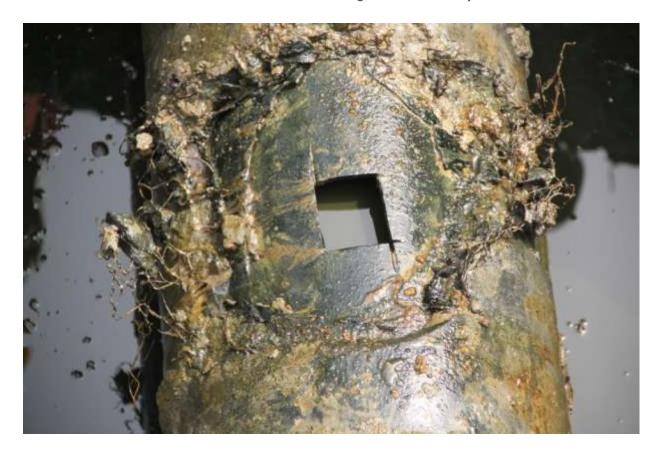
<u>Close-up:</u> Leak from a hole on 12" Benisede - Isampou Pipeline at Ekeremor. Picture was taken during JIV of 19 January 2011
