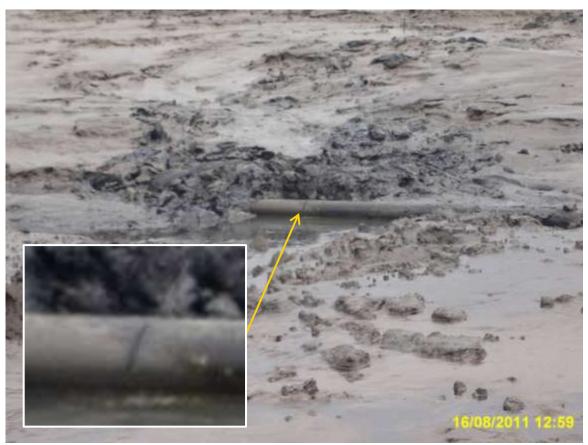
<u>Close-up:</u> Spill due to hacksaw cut on Akaso Well 10L flowline at Cawthorne Channel. Picture taken during Joint Investigation of 16th August, 2011.
