Overview: Extent of the spill incident impact at 24' Bomu-Bonny Pipeline at Moghor. Picture was taken during JIV of 10 March 2011

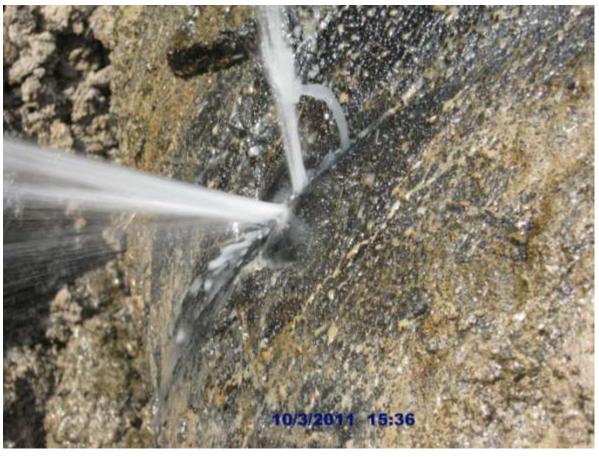
<u>Close-up:</u> Hacksaw cut on 24' Bomu-Bonny Pipeline at Moghor. Picture was taken during JIV of 10 March 2011
