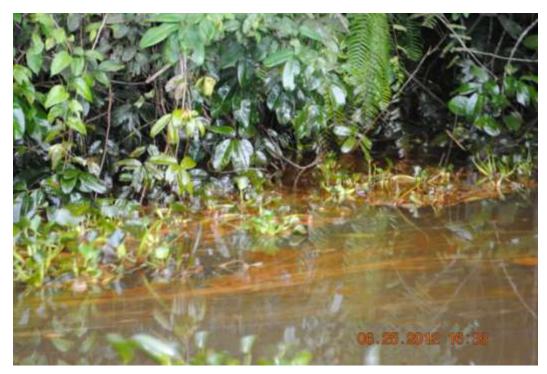
Overview: Part of spill impact on Opukushi Well24T flowline right of way at Agbemo-Angalebiri. Picture was taken during Joint Investigation of 30th June 2012.

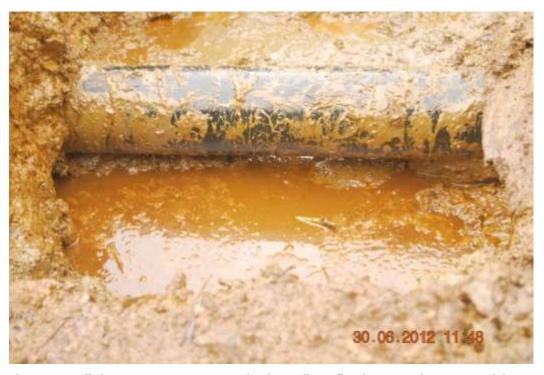
<u>Close up:</u> Spill due to corrosion on Opukushi Well24T flowline at Agbemo-Angalebiri. Picture was taken during Joint Investigation of 30th June 2012.

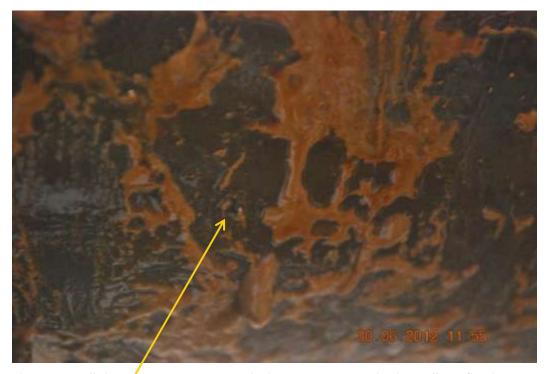
Close up: Spill due to corrosion at 6 o'clock position on Opukushi Well24T flowline at Agbemo-Angalebiri.
