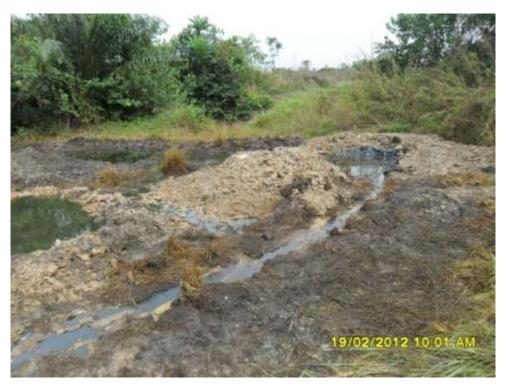
Overview: Part of spill impact on 12" Oguta-Egbema pipeline right of way at Obiakpu. Picture was taken during Joint Investigation of 19th February 2012.

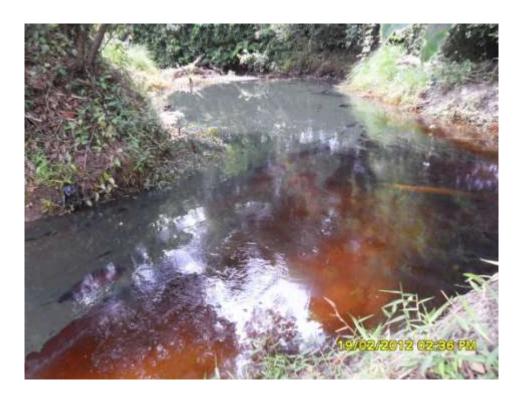
Overview: Part of spill impact on 12" Oguta-Egbema pipeline right of way at Obiakpu. Picture was taken during Joint Investigation of 19th February 2012.

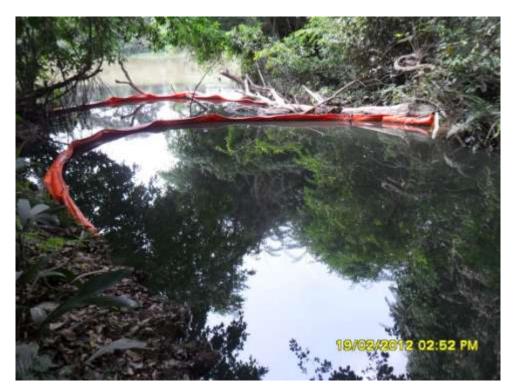
Overview: Part of spill impact on 12" Oguta-Egbema pipeline right of way at Obiakpu. Picture was taken during Joint Investigation of 19th February 2012.

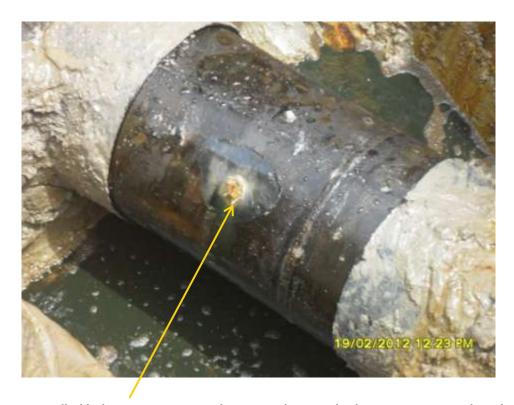
<u>Close-up:</u> Drilled hole on 12" Oguta-Egbema pipeline at Obiakpu. Picture was taken during Joint Investigation of 19th February 2012.
