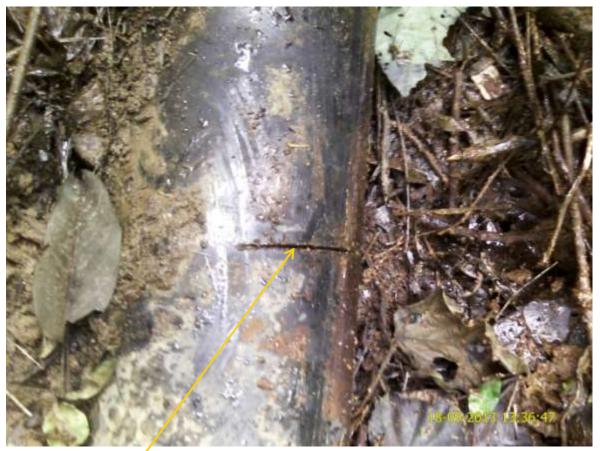
1

<u>Close up</u>: Hacksaw cut on 6" Imo River1 30L flowline at Igiriukwu. Picture was taken during Joint Investigation of 18th September 2013.
