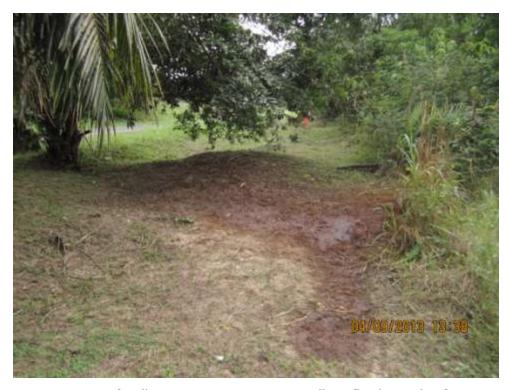
Overview: Part of spill impact on 4" Nun River Well13T flowline right of way at Oporoma. Picture was taken during Joint Investigation of 4th September 2013.

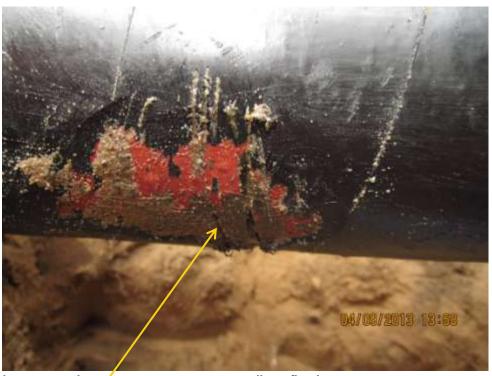
Close up: Hacksaw cut on 4" Nun River Well 13T flowline at Oporoma. Picture was taken during Joint Investigation of 4th September 2013.
