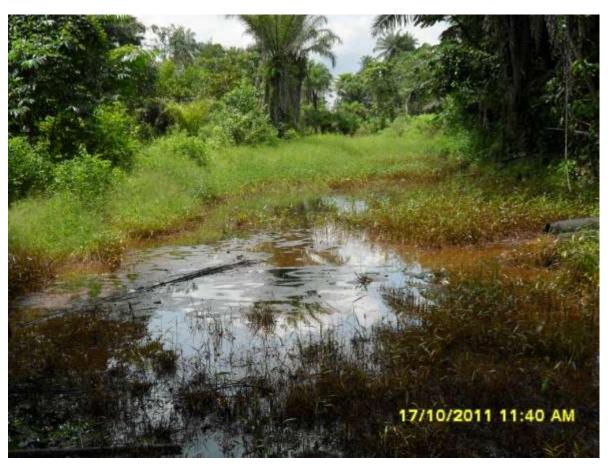
Overview: Part of spill impact on 12" Adibawa-Okordia pipeline at Ikarama. Picture was taken during Joint Investigation of 17th October, 2011.

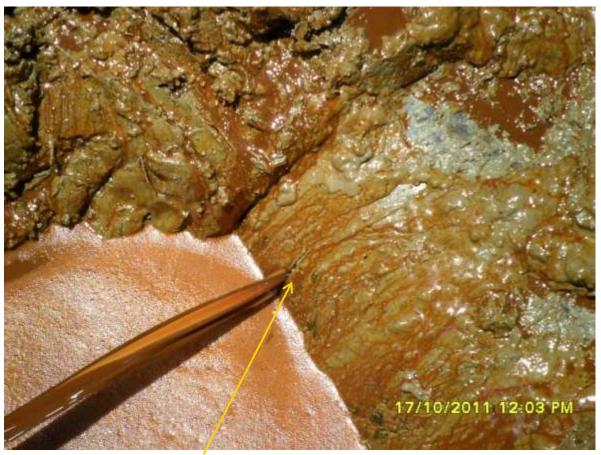
<u>Close-up:</u> Spill due to Hacksaw cut on 12" Adibawa-Okordia pipeline at Ikarama. Picture was taken during Joint Investigation of 17th October, 2011.
