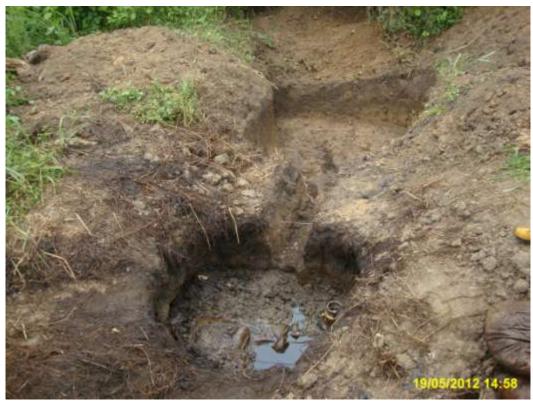
Overview: Part of spill impact on 12" Imo River1 pipeline right of way at Uzuaku. Picture was taken during Joint Investigation of 19th May 2012.

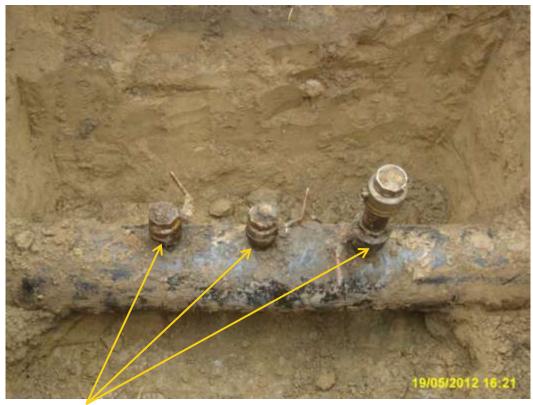
<u>Close up:</u> Illegal fittings on 12" Imo River1 pipeline at Uzuaku. Picture was taken during Joint Investigation of 19th May 2012.
