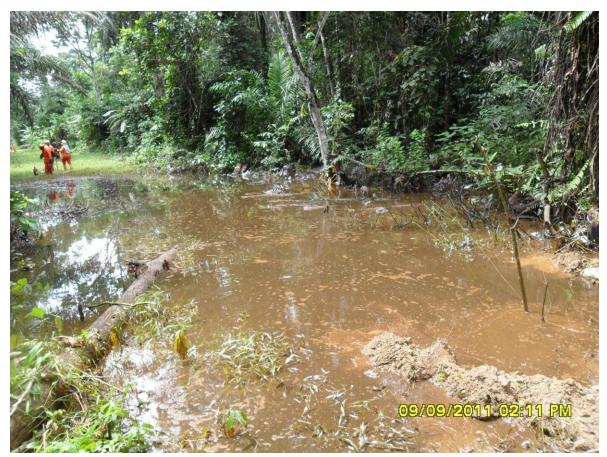
Overview: Part of spill impact on 14" Okordia – Rumuekpe Pipeline route at Ikarama . Picture was taken during Joint Investigation of 9th September, 2011.

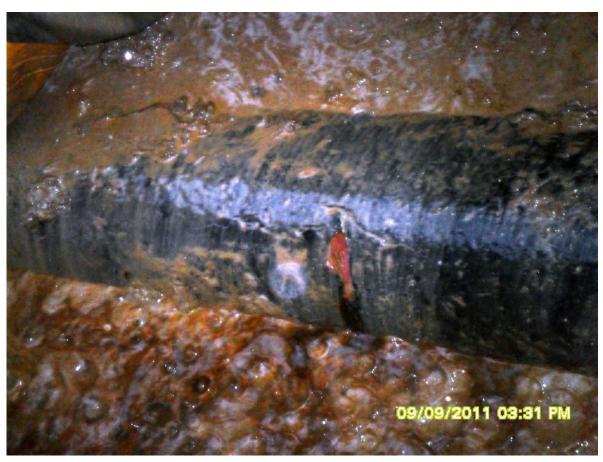
<u>Close-up:</u> Spill due to Hack saw cut on 14" Okordia – Rumuekpe Pipeline at Ikarama. Picture was taken during Joint Investigation of 9th September, 2011
