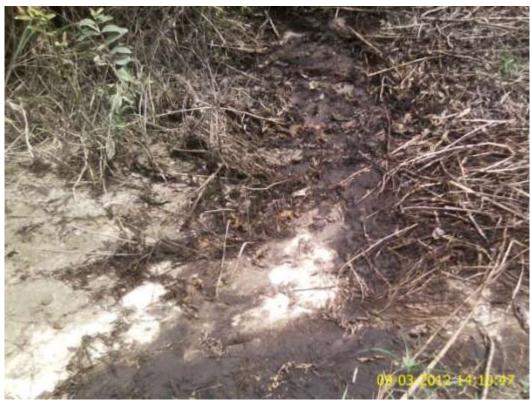
Overview: Part of spill impact on 12" Adibawa-Okordia pipeline right of way at Edagberi-Betterland. Picture was taken during Joint Investigation of 9th March 2012.

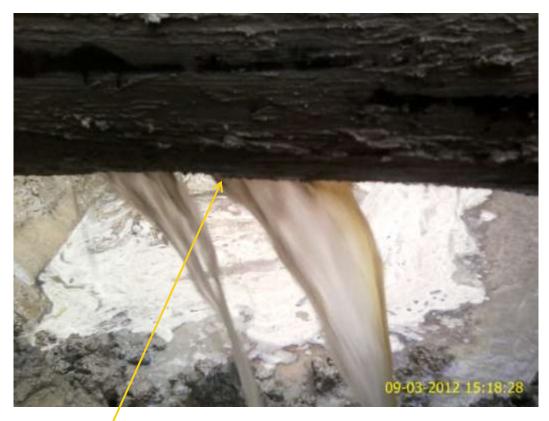
Close up: Tear at 6 o'clock position on 12" Adibawa-Okordia pipeline at Edagberi-Betterland. Picture was taken during Joint Investigation of 9th March 2012.
