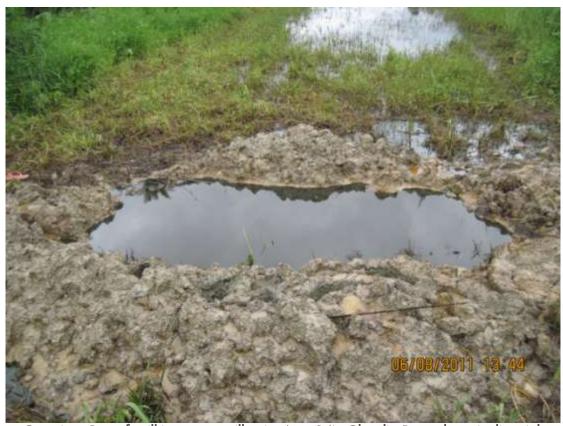
Overview: Part of spill impact at spill point A on 14in Okordia-Rumuekpe pipeline right of way at Ikarama. Picture taken during Joint Investigation of 6th August, 2011.

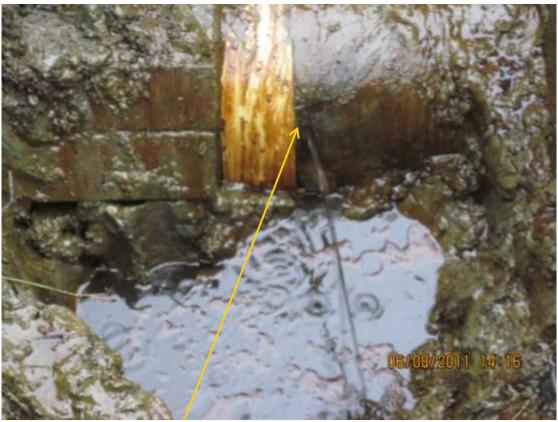
<u>Close-up:</u> Spill due to hacksaw cut on 14in Okordia-Rumuekpe pipeline at Ikarama. Picture taken during Joint Investigation of 6<sup>th</sup> August, 2011.
