Overview: Extent of the spill incident impact on  $8^{\prime\prime}$  Obigbo-North Pipeline at Obigbo . Pictures taken during Joint Investigation of  $25^{\rm th}$  March, 2011

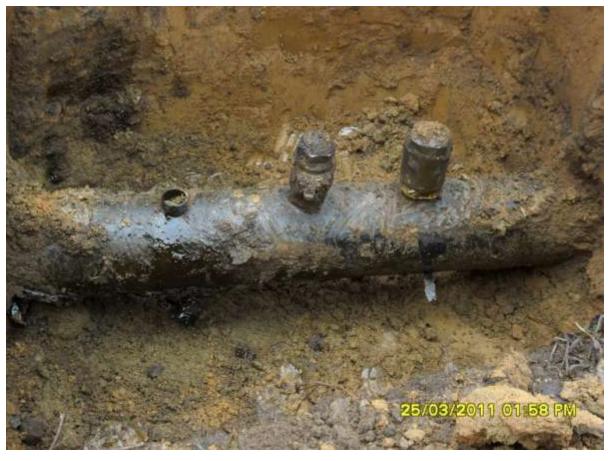
<u>Close-up:</u> Spill was due to illegally welded point on  $8^{\prime\prime}$  Obigbo-North Pipeline at Obigbo. Picture taken during Joint Investigation of  $25^{\text{th}}$  March, 2011.
