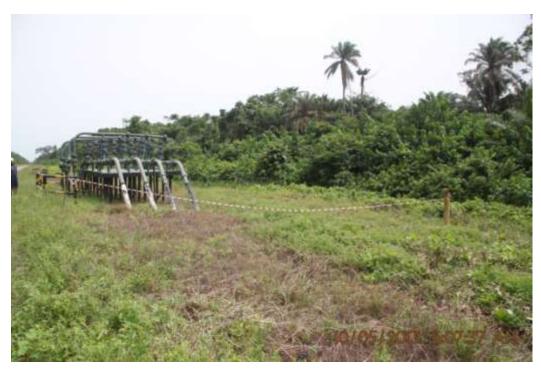
Overview: Part of spill impact on Yokri Manifold7 Low Pressure1 line right of way at Sokebolou. Picture was taken during Joint Investigation of 10th May 2013.

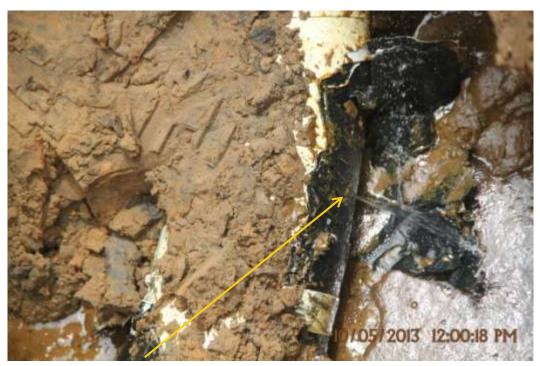
<u>Close up</u>: Leak due to corrosion on Yokri Manifold7 Low Pressure1 line at Sokebolou. Picture was taken during Joint Investigation of 10th May 2013.
