Overview: Part of the spill impact on Cawthorne channel 2 Well 32S flowline right of way at Mbiama. Picture taken during Joint Investigation of 28th June, 2011

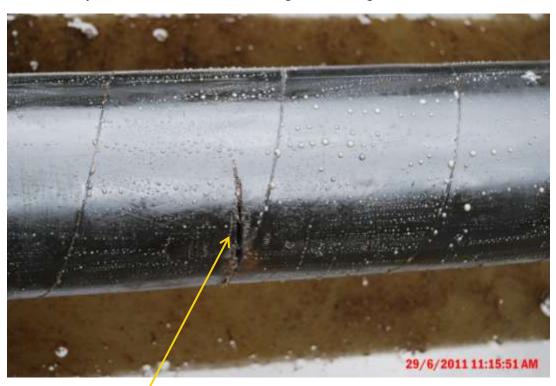
<u>Close-up:</u> Spill due to hacksaw cut on Cawthorne channel 2 Well 32S flowline at Mbiama. Picture taken during Joint Investigation of 29th June, 2011.
