Overview: Extent of the spill incident impact at 24" Nembe Creek Trunkline (old NCTL) Pipeline route in Tora-Twenikiri . Picture was taken during JIV of 4 February 2011

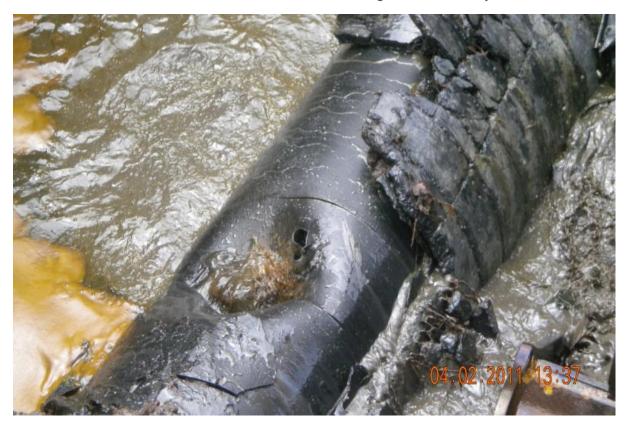
<u>Close-up:</u> Illegally welded/dented point on 24" Nembe Creek Trunkline (old NCTL)
Pipeline at Tora-Twenikiri. Picture was taken during JIV of 4 February 2011
