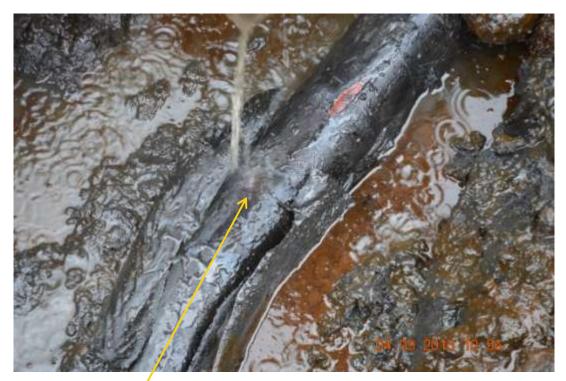
1

<u>Close up</u>: Spill due to corrosion on 4" Cawthorne Channel 2 Well 29T flowline at Mbiama. Picture was taken during Joint Investigation of 4th September 2013.
