Overview: Parts of spill impact on 14" Okordia - Rumuekpe Pipeline riser at Akinima.

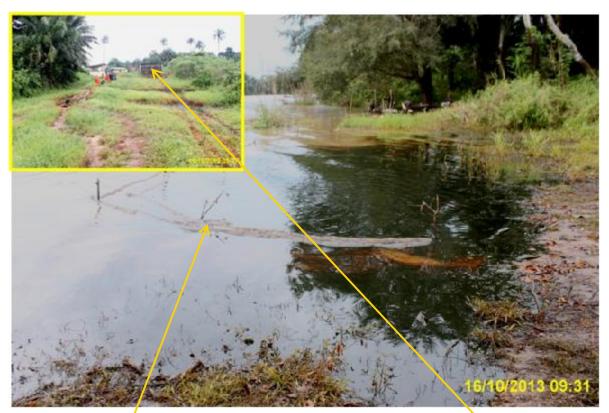
Boom in place Picture was taken during Joint Investigation of 16th October 2013.

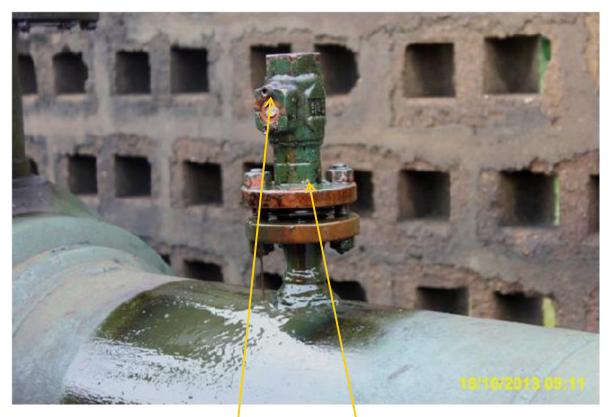
Close up: Positions of tampered valve and missing nuts & bolts on 14" Okordia - Rumuekpe Pipeline riser at Akinima. Picture was taken during Joint Investigation of 16th October 2013.
