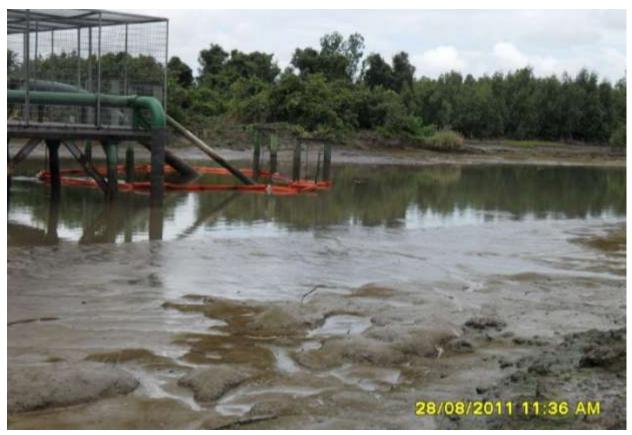
Overview: Part of the spill impact on 10" Ekulama-Sanbarth pipeline at Sanbarth. Picture taken during Joint Investigation of 28th August 2011

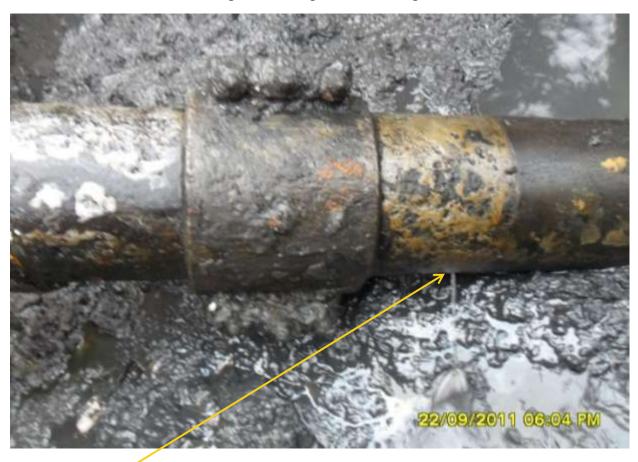
<u>Close-up:</u> Spill point due to corrosion on 10" Ekulama-Sanbarth pipeline at Sanbarth. Picture taken during Joint Investigation of 22nd September, 2011
