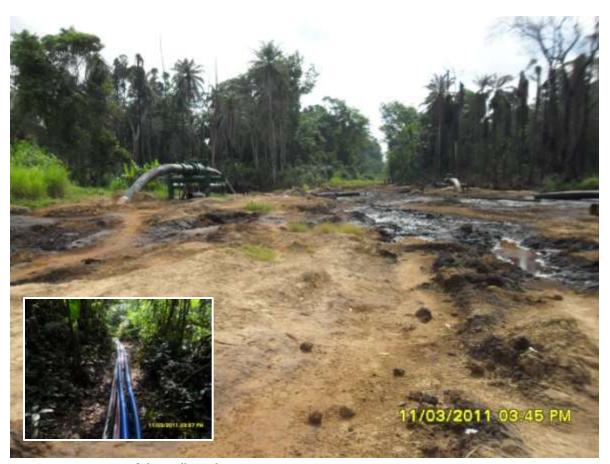
Overview: Extent of the spill incident impact at 20' Kolocreek-Rumuekpe Pipeline at Ogbogolo. Insert showing bunkering hoses from the site. Picture was taken during JIV of 11 March 2011

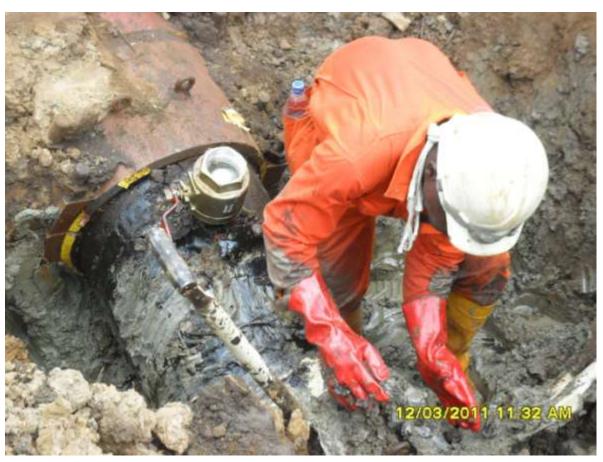
<u>Close-up:</u> Illegally welded point on 20' Kolocreek-Rumuekpe Pipeline at Ogbogolo. Picture was taken during JIV of 12 March 2011
