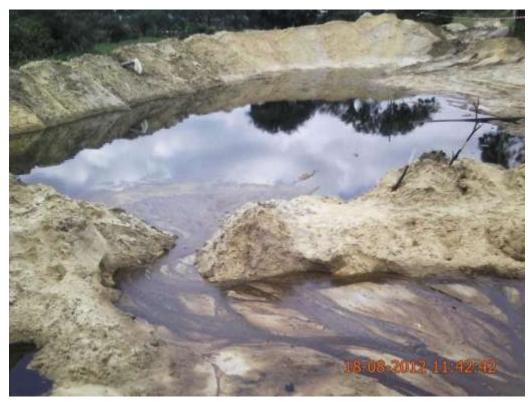
Overview: Part of spill impact on 28" Nkpoku-Bomu pipeline right of way at Ejamah-Ebubu. Picture was taken during site visit of 18th August 2012.

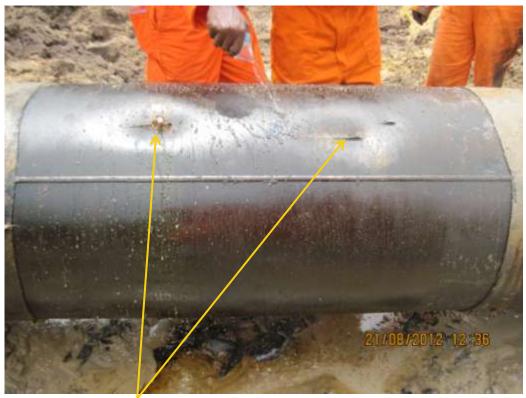
<u>Close up:</u> Damage due to 3rd party dredging equipment on 28" Nkpoku-Bomu pipeline at Ejamah-Ebubu. Picture was taken during Joint Investigation of 21st August 2012.
