Overview: Part of spill impact on 36" Rumuekpe-Nkpoku Trans Niger Pipeline right of way at Omuigwe-Aluu. Picture was taken during Joint Investigation of 3rd November 2013.

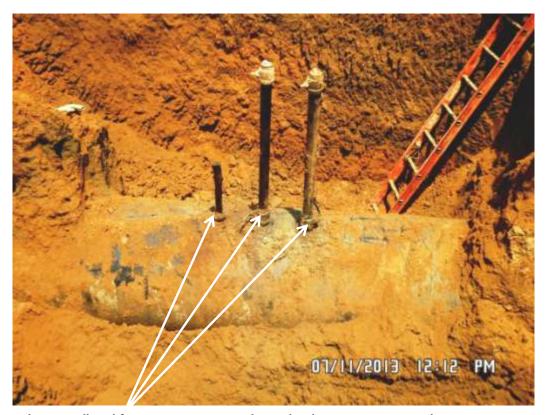
<u>Close-up:</u> Illegal fittings on 36" Rumuekpe-Nkpoku Trans Niger Pipeline at Omuigwe-<u>Aluu</u>. Picture was taken during Joint Investigation of 7th November 2013.
