Overview: Part of spill impact on 24" Bomu-Bonny pipeline right of way at Bodo West. Picture was taken during Joint Investigation of 30th June 2012.

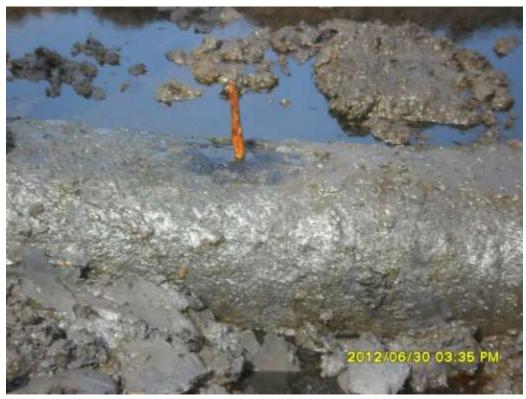
<u>Close up:</u> Spill point on 24" Bomu-Bonny pipeline at Bodo West. Picture was taken during Joint Investigation of 30th June 2012.

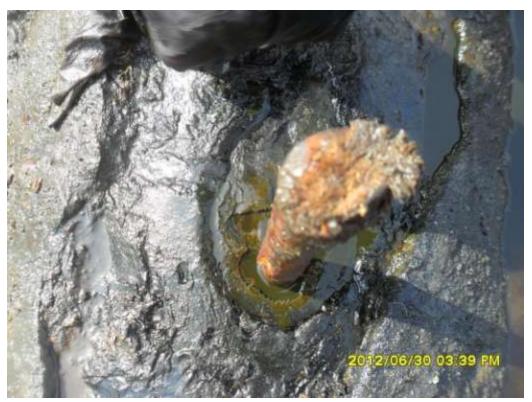
<u>Close up:</u> Spill point on 24" Bomu-Bonny pipeline at Bodo West. Picture was taken during Joint Investigation of 30<sup>th</sup> June 2012.
