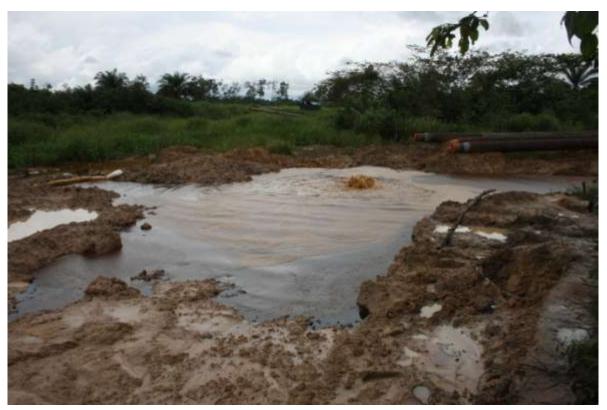
Overview: Part of spill impact on 6" Utorogu-Ughelli West gasline at lwhrekan. Picture taken during Joint Investigation of 25th August, 2011.

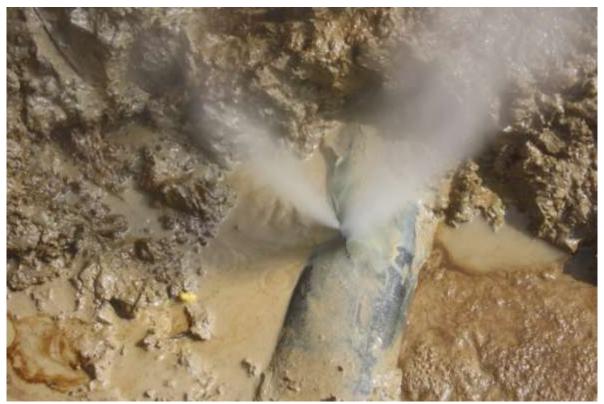
<u>Close-up:</u> Spill due to damage by 3rd party equipment on 6" Utorogu-Ughelli West gasline at Iwhrekan. Picture taken during Joint Investigation of 25th August, 2011.
