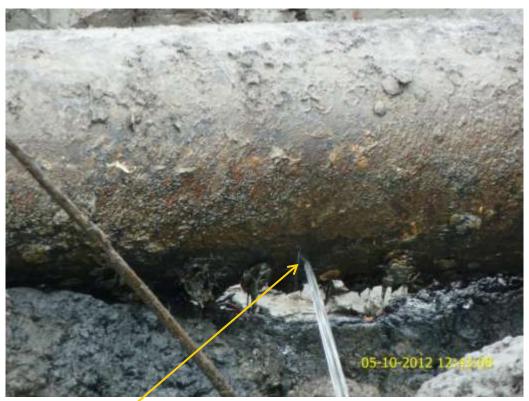
<u>Close up:</u> Spill point due to corrosion on 24" Bomu-Bonny Trans Niger pipeline at Freetown. Picture was taken during Joint Investigation of 5<sup>th</sup> October 2012.
