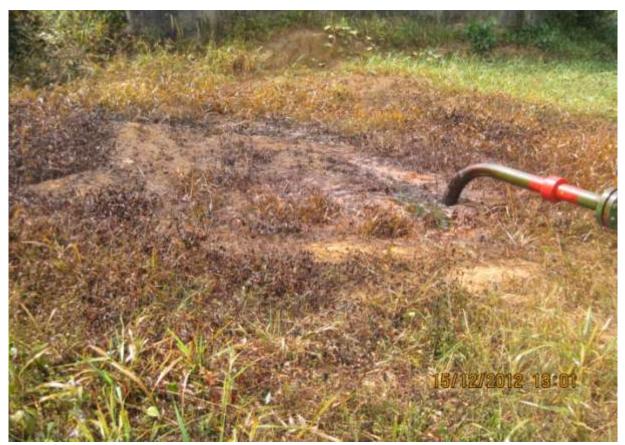
Overview: Part of spill impact on Umuechem Well 12L flowline at Umuechem. Picture was taken during Joint Investigation of 15th Dec. 2012.

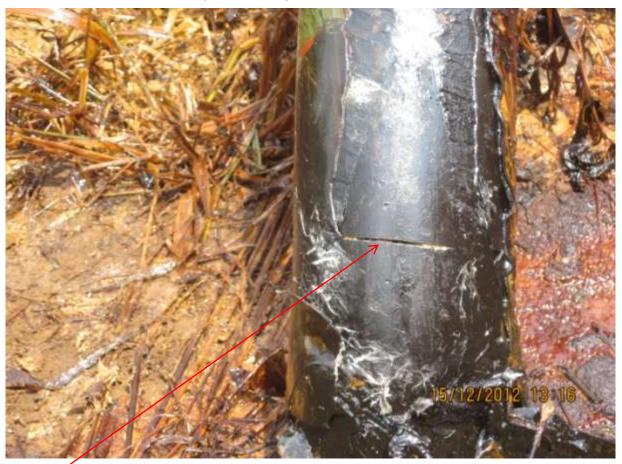
<u>Close-up:</u> Hacksaw cut on Umuechem Well 12L flowline at Umuechem. Picture was taken during Joint Investigation of 15th Dec. 2012.
