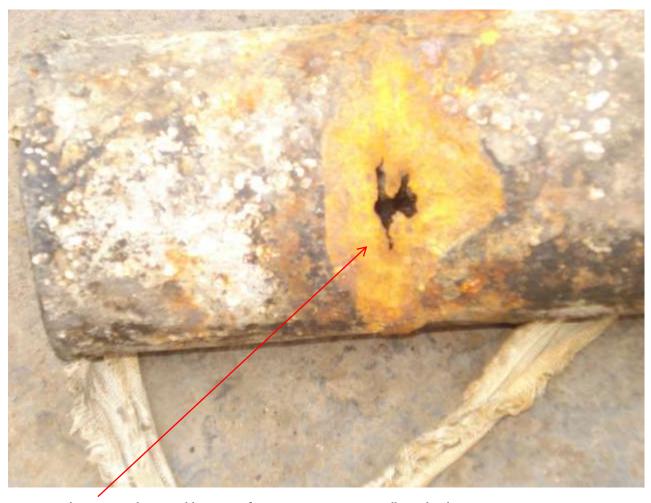
1

<u>Close-up:</u> Submerged location of corrosion on Bonny Well 2S Flowline at Bonny. Picture was taken after retrieval of failed section.
