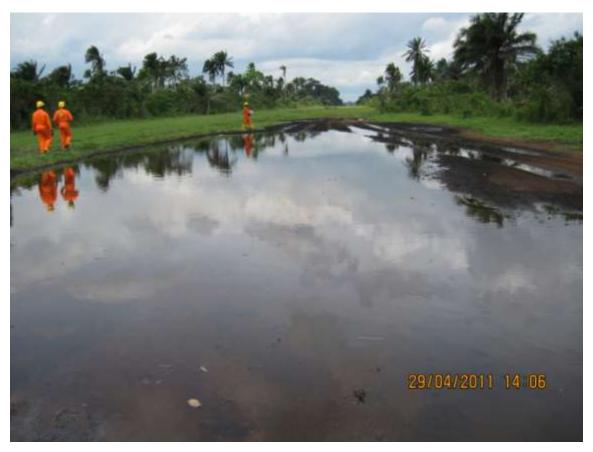
Overview: Extent of the spill incident impact at 36" Rumuekpe-Nkpoku Pipeline route in Aluu . Picture was taken during JIV of 29th April, 2011

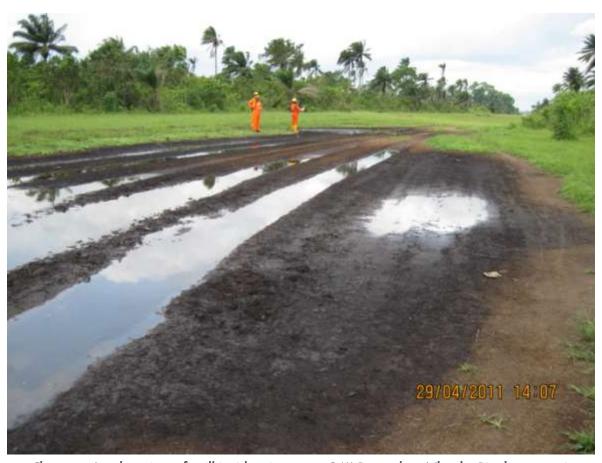
<u>Close-up:</u> Another view of spill incident impact at 36" Rumuekpe-Nkpoku Pipeline route in Aluu . Picture was taken during JIV of 29th April, 2011

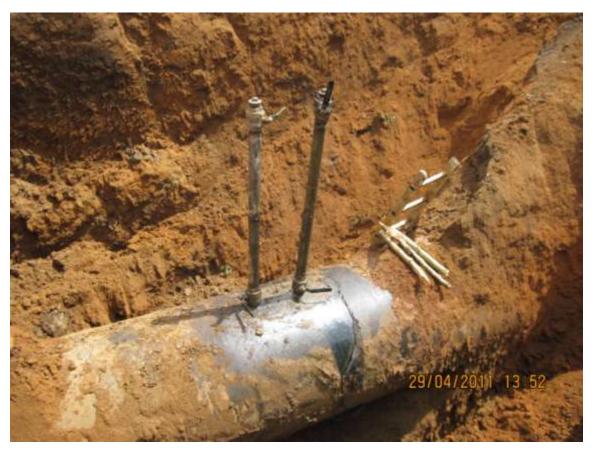
Overview: Illegally welded points on 36" Rumuekpe-Nkpoku Pipeline in Aluu. Picture was taken during JIV of 29th April, 2011

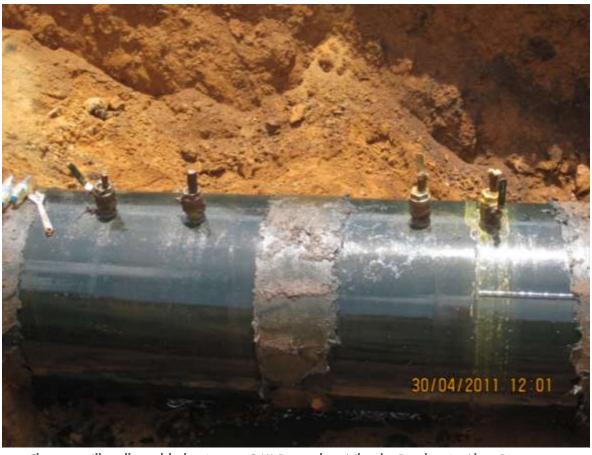
<u>Close-up:</u> Illegally welded points on 36" Rumuekpe-Nkpoku Pipeline in Aluu. Picture was taken on 30th April, 2011
