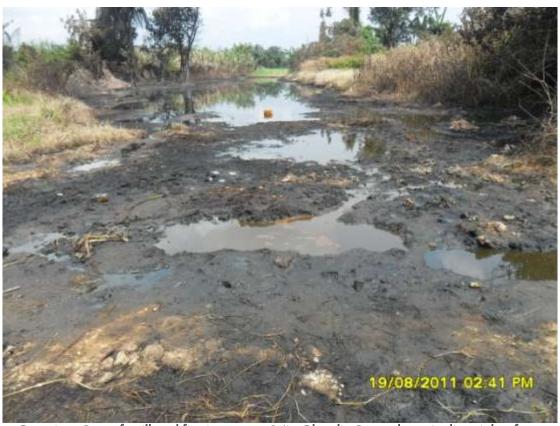
Overview: Part of spill and fire impact on 14in Okordia-Rumuekpe pipeline right of way at Ikarama. Picture taken during Joint Investigation of 19th August, 2011.

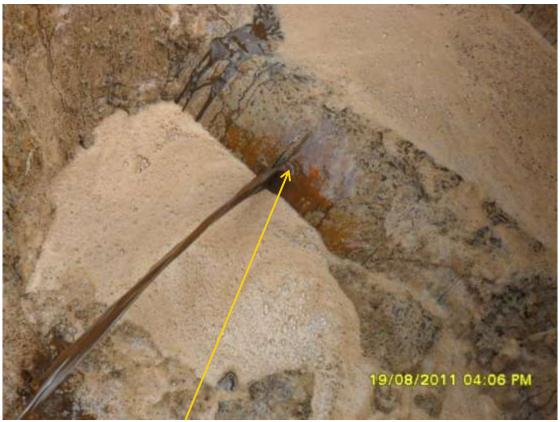
<u>Close-up:</u> Spill due to hacksaw cut on 14in Okordia-Rumuekpe pipeline at Ikarama.
Picture taken during Joint Investigation of 19th August, 2011.

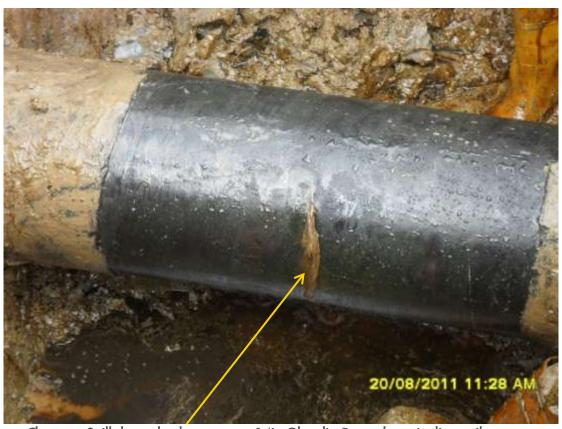
<u>Close-up:</u> Spill due to hacksaw cut on 14in Okordia-Rumuekpe pipeline at Ikarama. Picture taken during Joint Investigation of 19th August, 2011.
