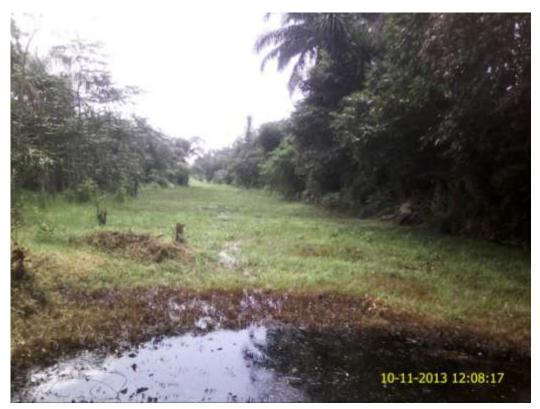
Overview: Part of spill impact on 24" Bomu-Bonny Pipeline right of way at Kpor. Picture was taken during Joint Investigation of 10th November 2013.

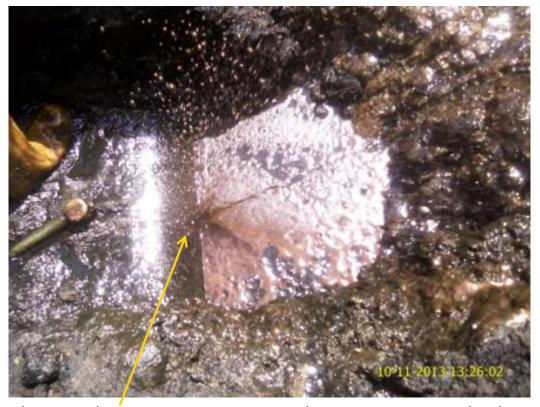
<u>Close-up:</u> Hacksaw cut on 24" Bomu-Bonny Pipeline at Kpor. Picture was taken during Joint Investigation of 10<sup>th</sup> November 2013.

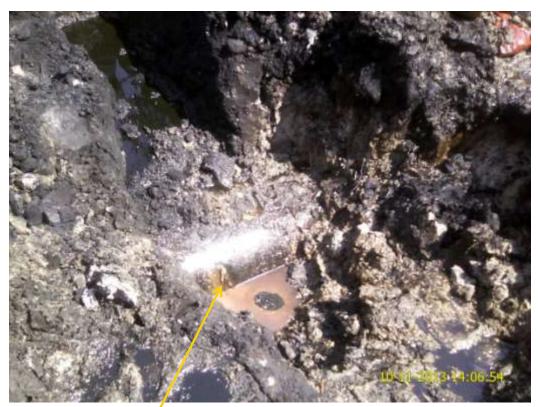
<u>Close-up:</u> Hacksaw cut on 24" Bomu-Bonny Pipeline at Kpor. Picture was taken during Joint Investigation of 10<sup>th</sup> November 2013.
