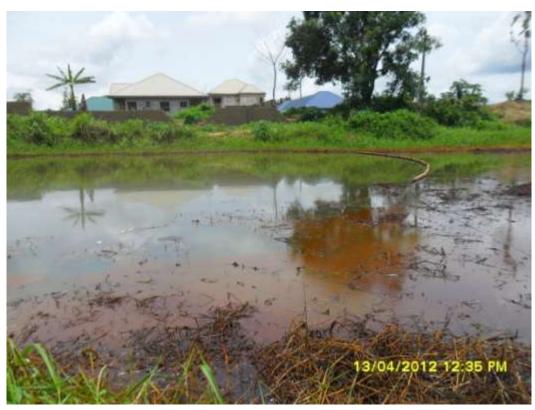
Overview: Part of spill impact on 8" Etelebou-Kolocreek pipeline right of way at Biogbolo. Picture was taken during Joint Investigation of 13th April 2012.

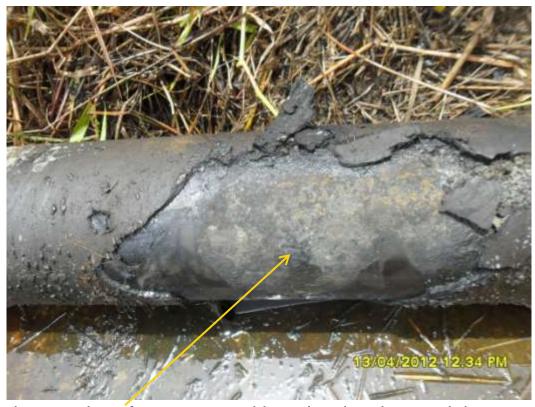
Close up: Evidence of corrosion on 8" Etelebou-Kolocreek pipeline at Biogbolo. Picture was taken during Joint Investigation of 13th April 2012.
