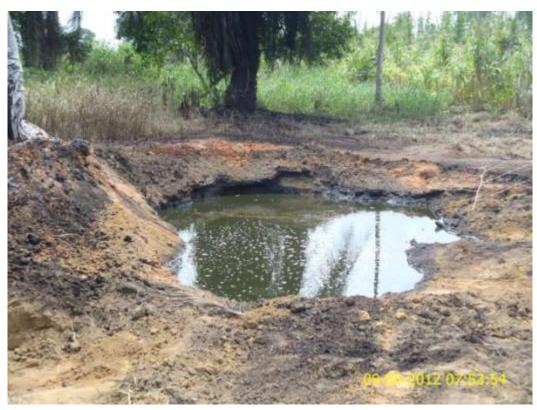
Overview: Part of spill impact on 24" Npoku-Bomu pipeline right of way at Bera. Picture was taken during Joint Investigation of 9th June 2012.

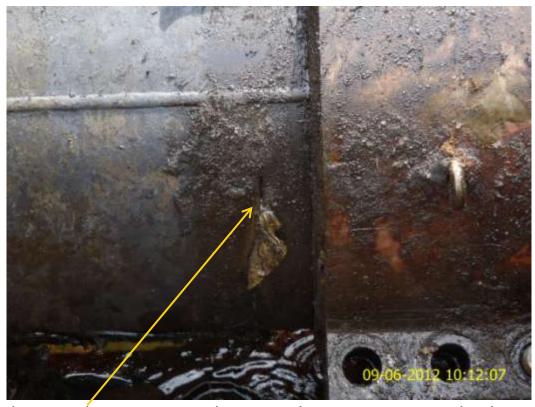
Close up: Hacksaw cut on 24" Npoku-Bomu pipeline at Bera. Picture was taken during Joint Investigation of 9th June 2012.
