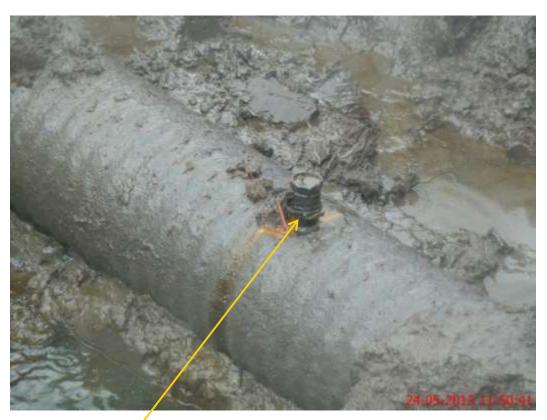
<u>Close up</u>: Illegal fitting on 28" Bomu-Bonny TransNiger pipeline at Bodo West. Picture was taken during Joint Investigation of 24<sup>th</sup> May 2013.
