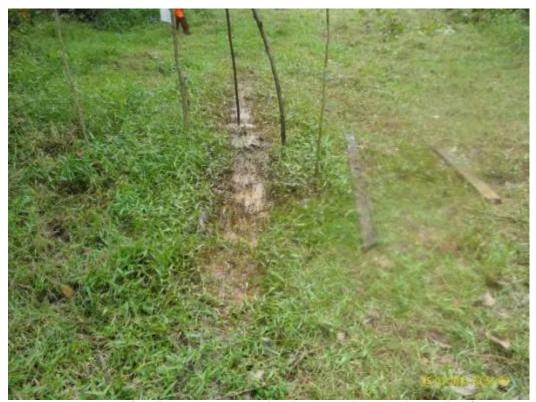
Overview: Part of spill impact on 14" Okordia-Rumuekpe pipeline right of way at Ikarama. Picture was taken during Joint Investigation of 15th March 2013.

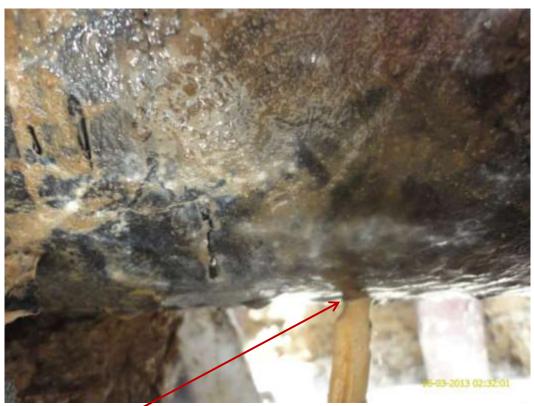
Close up: Location of corrosion point on 14" Okordia-Rumuekpe pipeline at Ikarama. Picture was taken during Joint Investigation of 16th March 2013.
