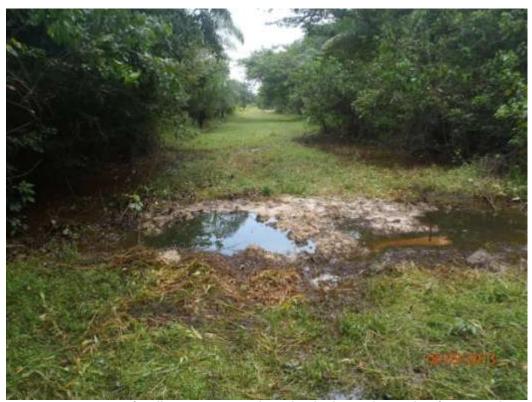
Overview: Part of spill impact on 8" Ubie-Ukpeliede pipeline right of way at Idu-Ekpeye. Picture was taken during Joint Investigation of 18th May 2013.

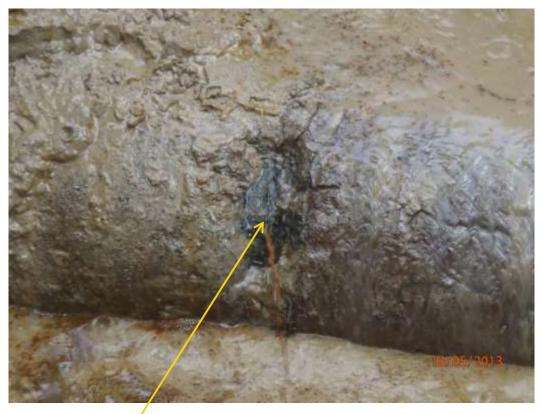
Close up: Spill due to hacksaw cut on 8" Ubie-Ukpeliede pipeline at Idu-Ekpeye.
Picture was taken during Joint Investigation of 18th May 2013.
