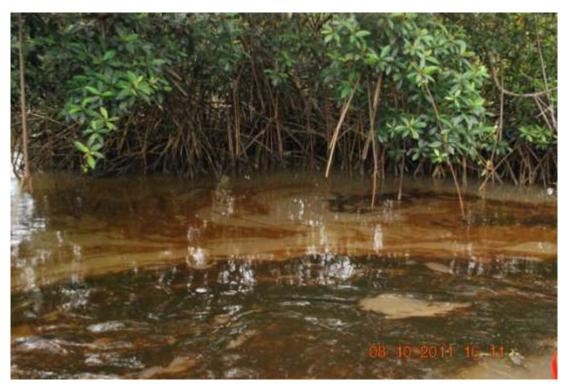
Overview: Part of spill impact on 28" Trans Forcados pipeline right of way at Batan. Picture taken during Joint Investigation of 8th October, 2011.

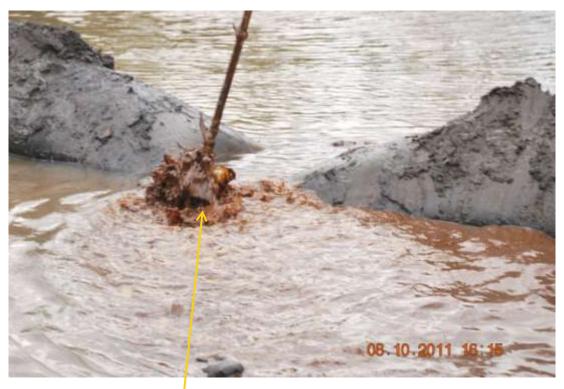
<u>Close-up:</u> Spill due to inward dent on 28" Trans Forcados pipeline at Batan. Picture taken during Joint Investigation of 8th October, 2011.
