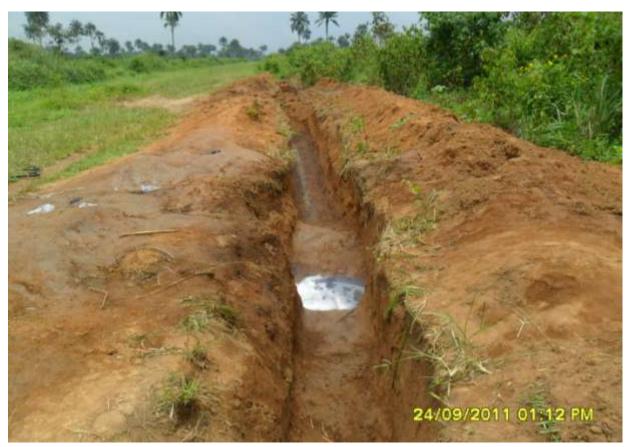
Overview: Part of the spill impact on 6" Obigbo North-Ogale pipeline right of way at Ogale Picture taken during Joint Investigation of 24th September, 2011

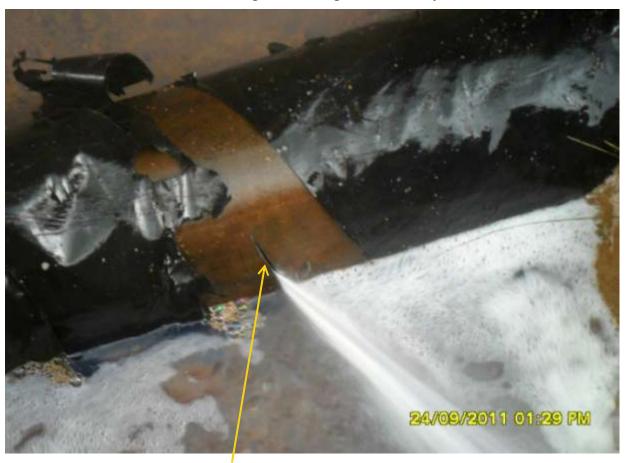
<u>Close-up:</u> Spill point due to hacksaw cut on 6" Obigbo North-Ogale pipeline at Ogale. Picture taken during Joint Investigation of 24th September, 2011
