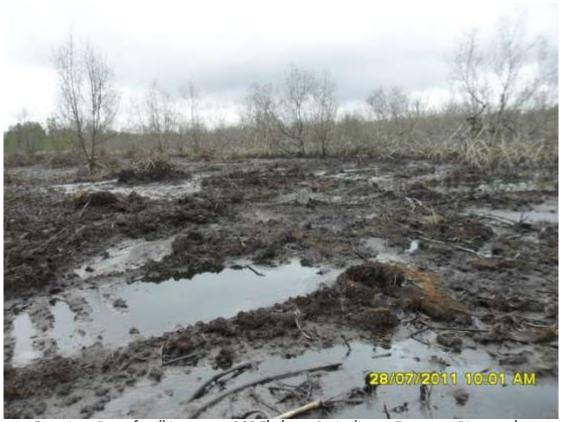
Overview: Part of spill impact on 10" Ekulama 1 pipeline at Freetown. Picture taken during Joint Investigation of 28th July, 2011.

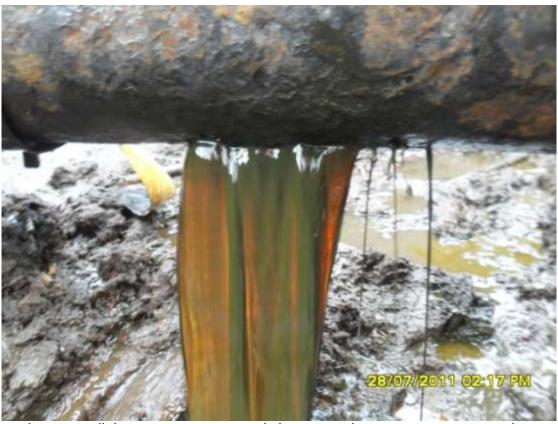
Close-up: Spill due to corrosion on 10" Ekulama 1 pipeline at Freetown. Picture taken during Joint Investigation of 28th July, 2011.
