Overview: Part of spill impact on Kanbo Well7S flowline right of way at Egbemoangarabiri/Agbidiama.

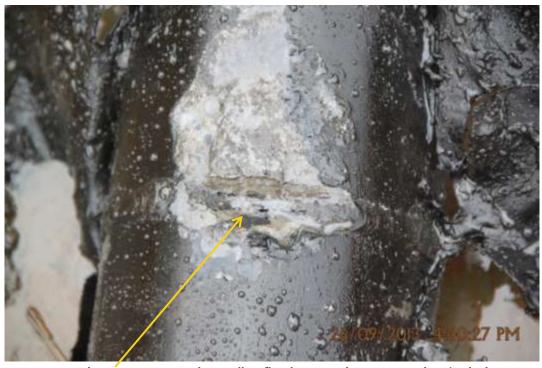
<u>Close up</u>: External corrosion on Kanbo Well7S flowline at Egbemoangarabiri/Agbidiama. Picture was taken during Joint Investigation of 26th September 2013.
