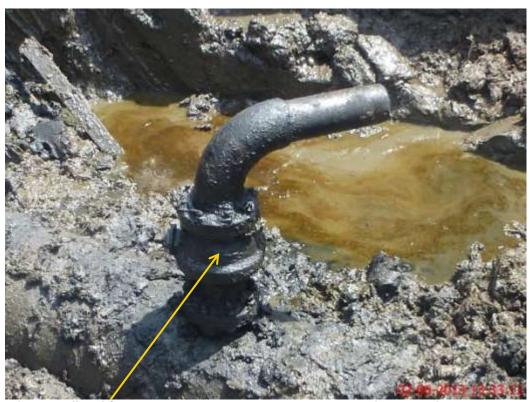
<u>Close up:</u> Illegal fitting on 24" Bomu-Bonny Trans Niger pipeline at BodoWest. Picture was taken during Joint Investigation of 2nd June 2013.

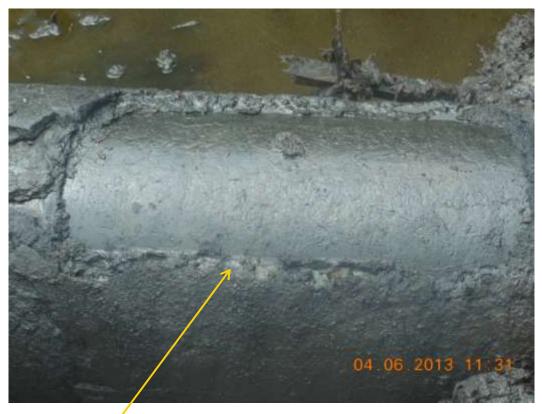
<u>Close up</u>: Section with coating removed on 24" Bomu-Bonny Trans Niger pipeline at BodoWest. Picture was taken during Joint Investigation of 4th June 2013.
