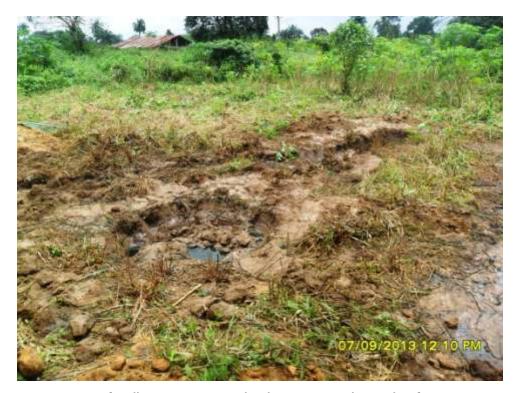
Overview: Part of spill impact on 24" Nkpoku-Bomu pipeline right of way at BDere. Picture was taken during Joint Investigation of 7th September 2013.

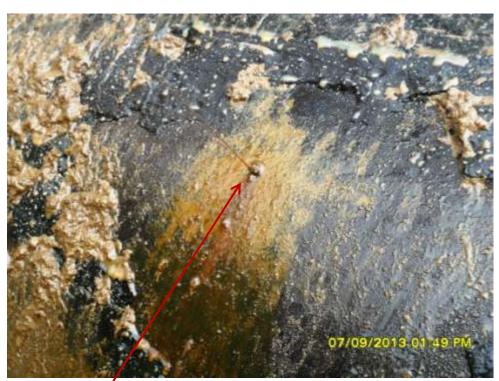
Close up: Drilled hole on 24" Nkpoku-Bomu pipeline at BDere. Picture was taken during Joint Investigation of 7th September 2013.
