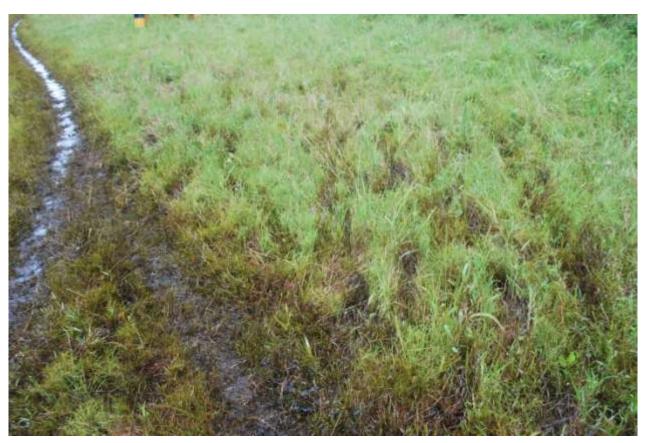
Overview: Part of spill impact on 16" Uzere - Eriemu Trunkline at Iyede. Picture was taken during Joint Investigation of 18th Sept. 2012.

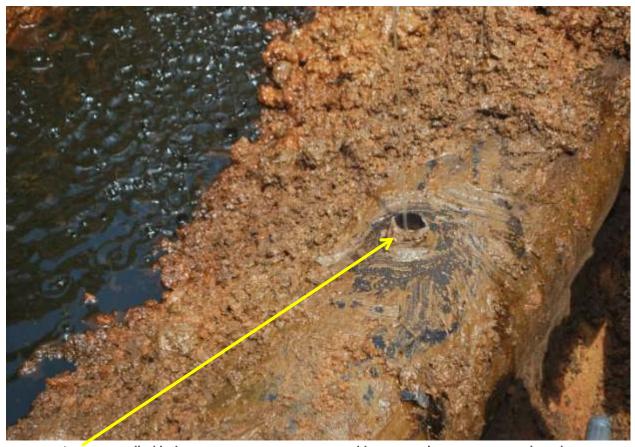
<u>Close-up:</u> Drilled hole on 16" Uzere - Eriemu Trunkline at Iyede. Picture was taken during Joint Investigation of 18th Sept. 2012.
