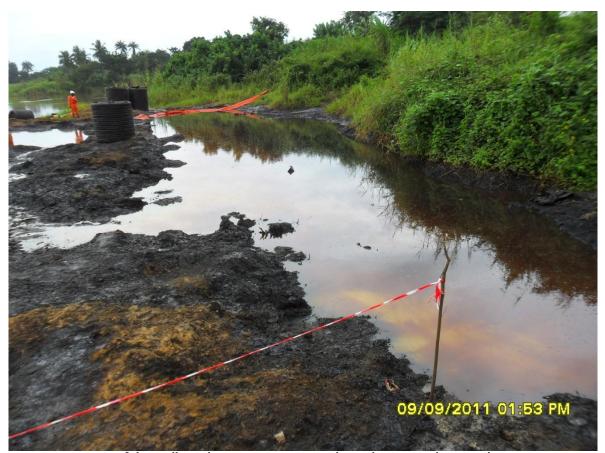
Overview: Part of the spill incident impact at 20" Kolocreek – Rumuekpe Pipeline route in Ogbogolo. Picture was taken during JIV of 4th and 9 – 11thSeptember, 2011.

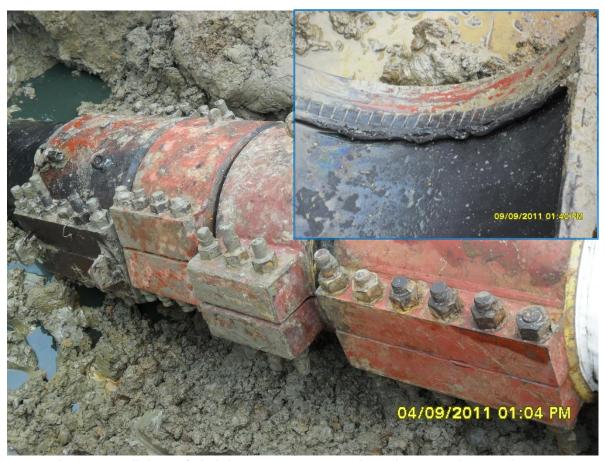
<u>Close-up:</u> Spill due to failed clamp point on 20" Kolocreek – Rumuekpe Pipeline at Ogbogolo. Insert shows broken seal of failed clamp. Pictures were taken during JIV of 4th and 9 – 11th September, 2011.
