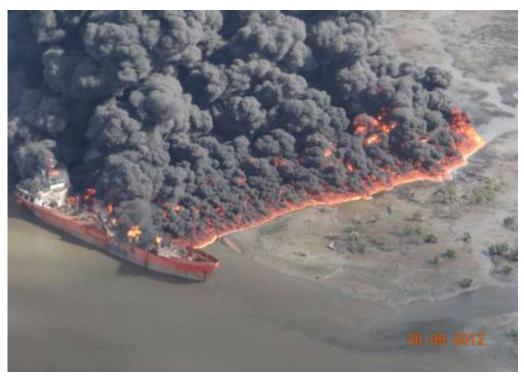
Overview: Burning crude theft supertanker on 28" Bomu-Bonny Tran Niger pipeline right of way at Okolo. Picture was taken during overfly of 30th September 2012.

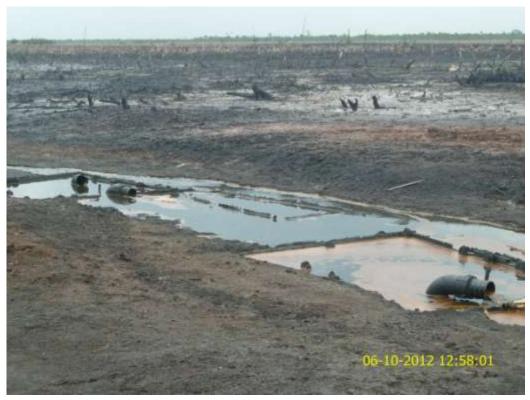
Overview: Part of spill impact on 28" Bomu-Bonny Tran Niger pipeline right of way at Okolo. Picture was taken during Joint Investigation of 6<sup>th</sup> October 2012.

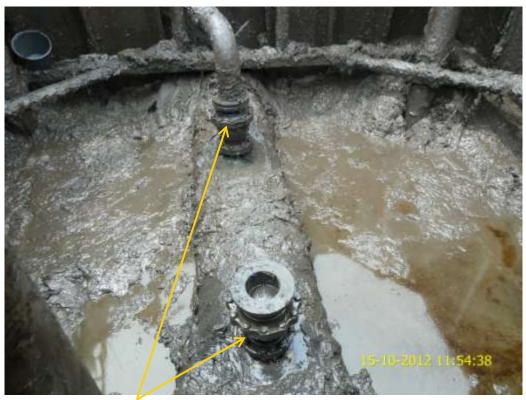
<u>Close up:</u> Illegal fittings on 28" Bomu-Bonny Tran Niger pipeline at Okolo. Picture was taken during Joint Investigation of 15<sup>th</sup> October 2012.

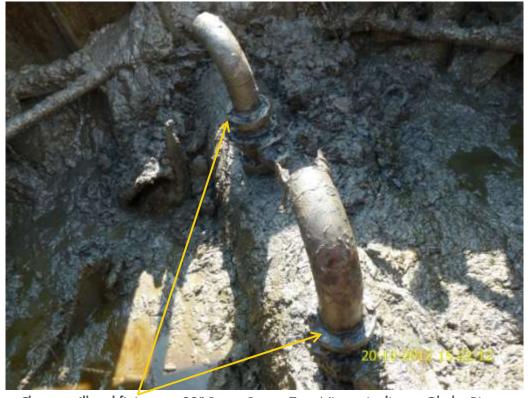
<u>Close up:</u> Illegal fittings on 28" Bomu-Bonny Tran Niger pipeline at Okolo. Picture was taken during Joint Investigation of 20<sup>th</sup> October 2012.
