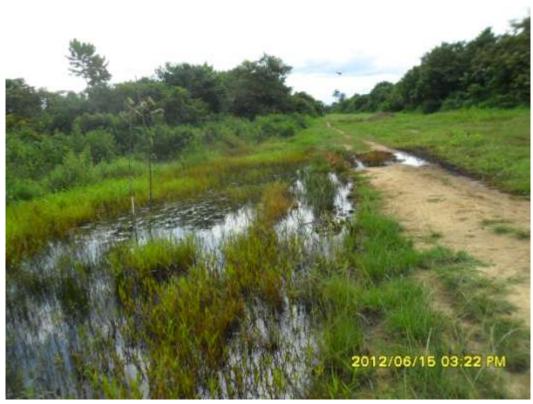
Overview: Part of spill impact on 24" Npoku-Bomu pipeline right of way at Ogale. Picture was taken during Joint Investigation of 15th June 2012.

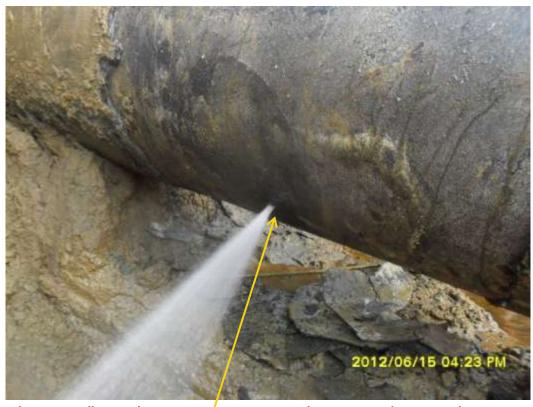
Close up: Spill point due to corrosion on 24" Npoku-Bomu pipeline at Ogale. Picture was taken during Joint Investigation of 15th June 2012.
