Overview: Part of spill impact on 10" Diebu Creek – Nun River pipeline right of way at Onyoma/Eniwari. Picture was taken during Joint Investigation of 22nd June 2013.

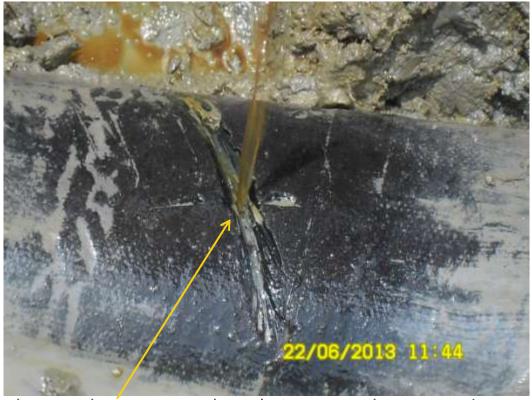
<u>Close up</u>: Hacksaw cut on 10" Diebu Creek – Nun River pipeline at Onyoma/Eniwari. Picture was taken during Joint Investigation of 22nd June 2013.
