Nontoxic Antifouling Strategies Demonstration Project

Visual Assessment of the Nontoxic Boat Bottom Coatings Demonstration Project at Final Haulout

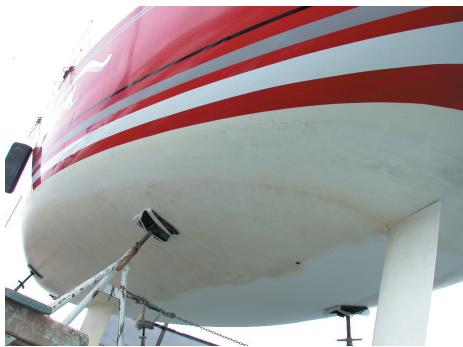
- The powerboat and the sailboat with the silicone coating had nearly new coating conditions after a year. The sailboat had the new formula of the silicone coating applied after 13 months to increase the slickness of the bottom for racing. The powerboat also had the new silicone formula applied. With the new formula, the performance of the coating improved for both vessels.

Sailboat- Silicone (1 year)

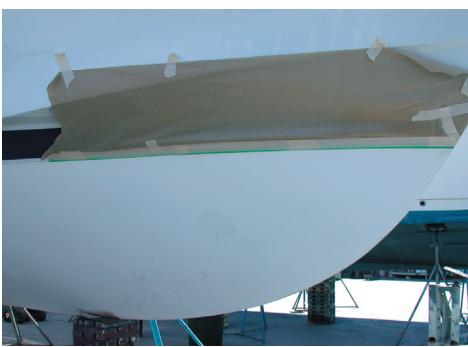
Powerboat- Silicone prepped to receive new formula

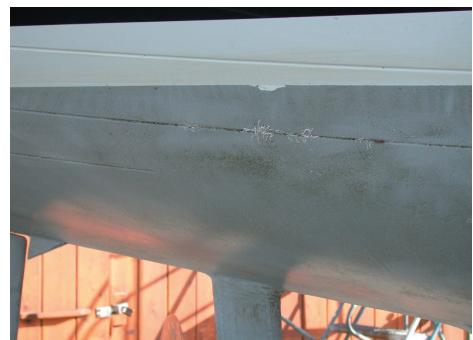
- The powerboat and the sailboat with ceramic epoxy coatings had nearly new coating conditions with only minor scarring from calcareous growth after one year. The coatings had a sheen but no shine. The coating was sprayed on the sailboat and rolled on the powerboat. The pores from the roller application on the powerboat were fouled as they are a prime area for marine organisms to grow.

Diesel Electric- Ceramic Epoxy (14 months) with tubeworm remnants

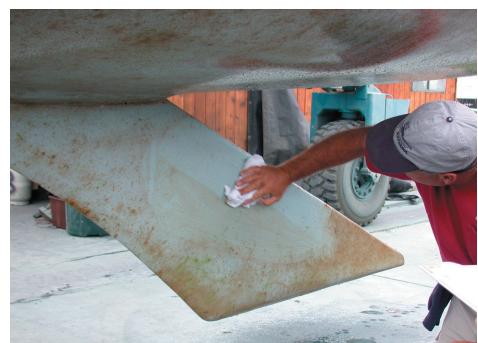
Sailboat- Ceramic Epoxy (5 months) after 13 days of growth

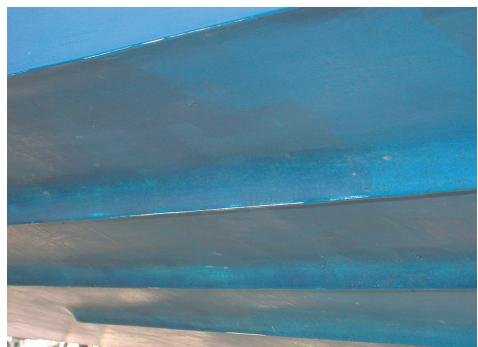
- The powerboat coated with an epoxy coating also had nearly new coating condition after one year with some wearing on the edges of the chines and light etching on the surface due to cleaning.

Powerboat- Epoxy (15 months) with wearing on edges of chines

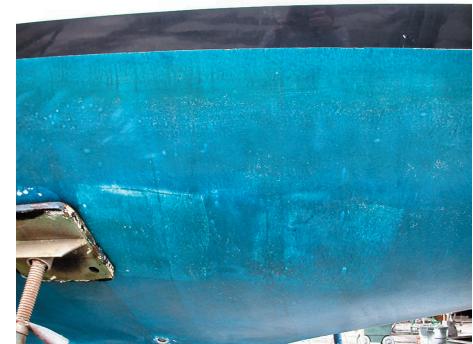
- The other vessel with an epoxy coating entered the project when the coating was almost 4 years old. By the end of the project, this epoxy coating was almost 5 years old and was expected by the boatyard operator to last another two years. The coating condition was rated at a level 3 out of 5 with some blemishes or defects on up to 20% of the boat bottom.

Sailboat- Epoxy (almost 5 years)
